**BOEING 737 9M-MBD—REPORT 1/78
ACCIDENT NEAR GELANG PATAH, NEGERI JOHOR**

**BOEING 737 9M-MBD
REPORT ON THE ACCIDENT AT TANJUNG KUPANG,
GELANG PATAH JOHOR BAHRU,
ON 04 DECEMBER, 1977**

Aircraft Accident Report No: 1/78

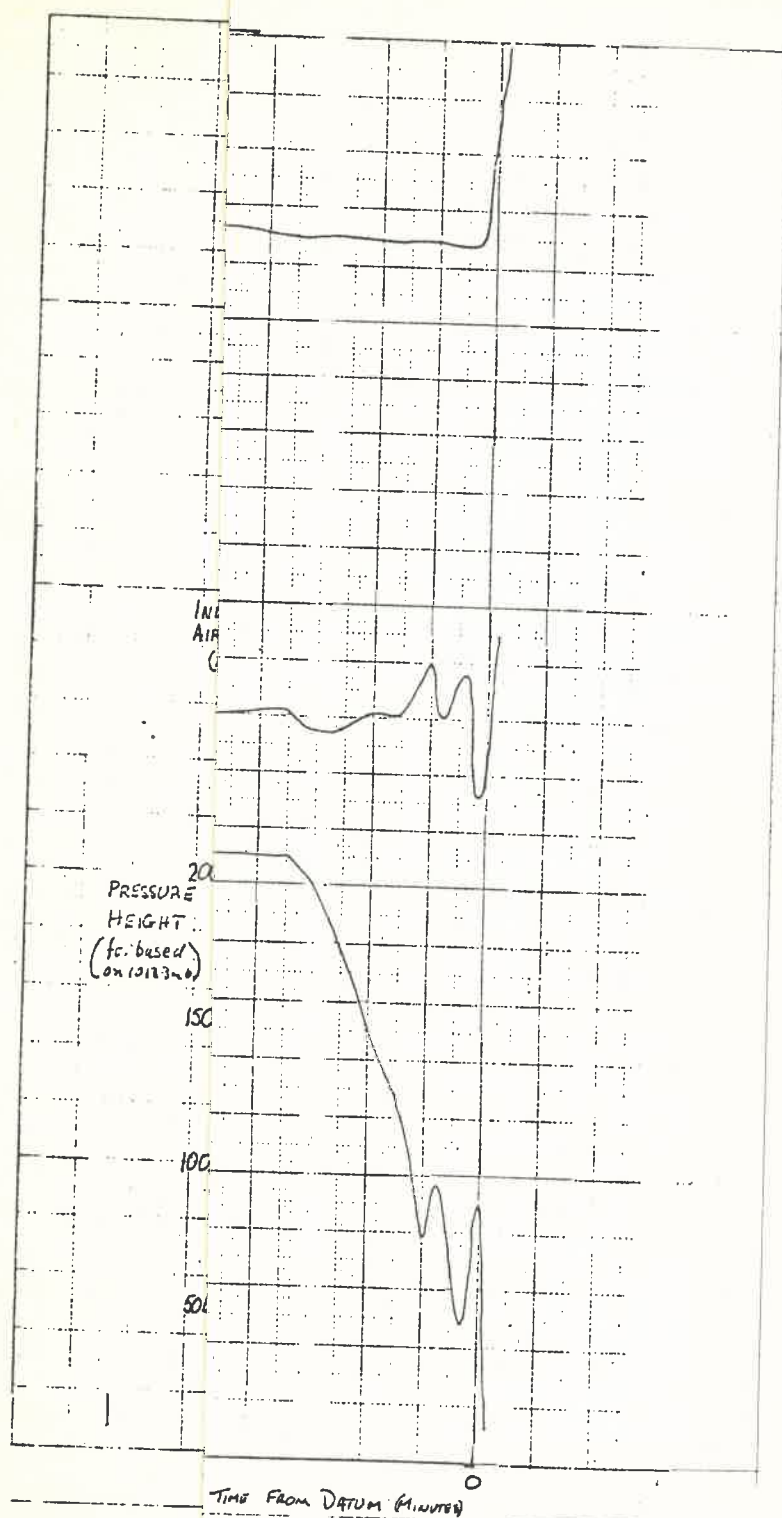
PROVISIONAL F.D.R. DATA & APPROXIMATE FLIGHT PROFILE

Both engines were severely damaged, with compressor discs liberated and separation having occurred at one or more case flanges, but sufficient evidence remained to indicate that both were rotating under some degree of power at impact and the related thrust reversers were in the forward thrust position. It was not considered necessary to proceed with a detailed engine investigation to determine more accurately the actual degree of power for reasons already given. Estimation of the actual power setting was subsequently produced as part of a computer analysis of the terminal manoeuvres. (See Section 1-16).

* DASHED LINES INDICATE AREAS WHERE DATA WAS UNOBTAINABLE DUE TO FAIL DAMAGE
